Manhole Inspection Summary

Manhole # S45U__007MH

Insp Date: **3/5/08 10:30 AM**

Location Address: **1300 hull st.**

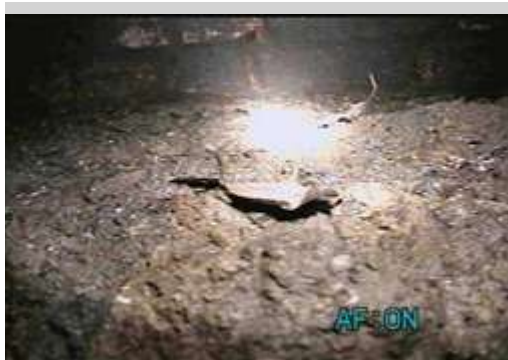
Defect 3

bench debris

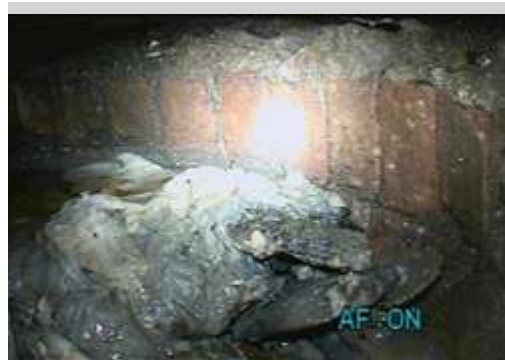
Defect 2

channel defect

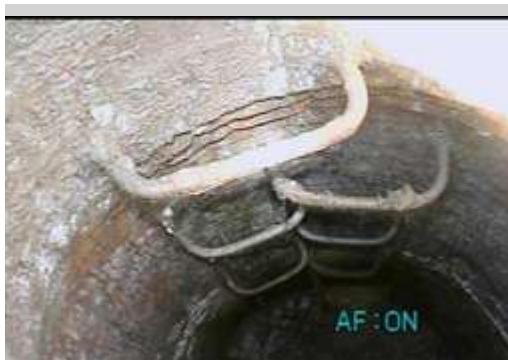
Defect 1

Steps Count: **6** Missing: **1** ☒ **Corroded**

steps defect

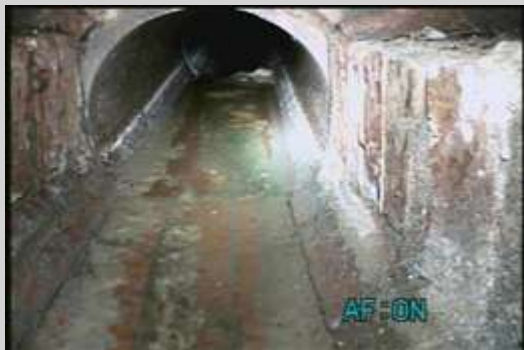
12 O'Clock Outflow

8 in. Circular Gravity Sewer
Pipe Out @ 12 O'Clock

Pipe Material: **Clay** ☐ Pipe Lined

Invert Depth: **10.30** (ft.) Flow Characteristics: **Slow**

Infiltration: **None** Pipe Seal Cond: **Unknown**

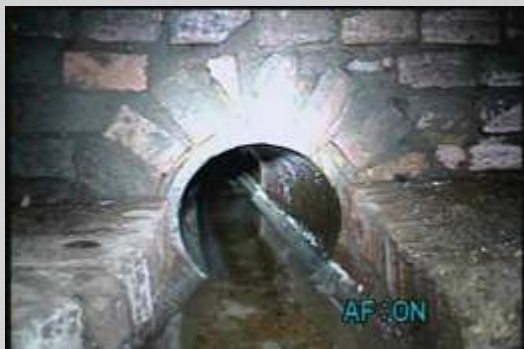
4 O'Clock Inflow

8 in. Circular Gravity Sewer
Pipe In @ 4 O'Clock

Pipe Material: **Clay** ☐ Pipe Lined

Invert Depth: **10.20** (ft.) Flow Characteristics: **Slow**

Infiltration: **None** Pipe Seal Cond: **Unknown**
